Manhole Inspection Summary

Manhole # S09AA2017MH

Insp Date: **8/2/06 10:15 AM**

Location Address: **5719 RUSK AVE**

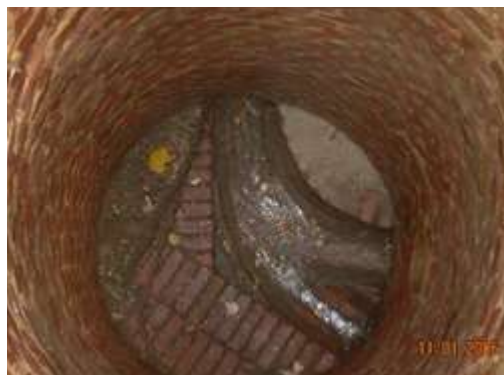
Top View

Adjustment and Corbel infiltration. Bench debris.

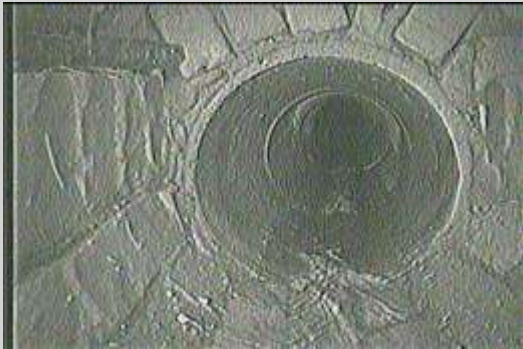
10 in. Circular Gravity Sewer Pipe Out @ 12 O'Clock

Pipe Material: **Clay** ☐ Pipe Lined

Invert Depth: **10.65** (ft.) Flow Characteristics: **Fast**

Infiltration: **None** Pipe Seal Cond: **Cracked**

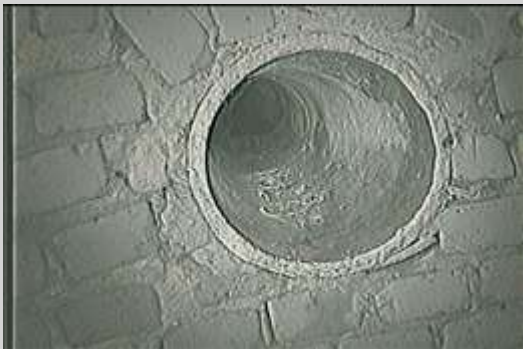
8 in. Circular Gravity Sewer Pipe In @ 4 O'Clock

Pipe Material: **Clay** ☐ Pipe Lined

Invert Depth: **8.12** (ft.) Flow Characteristics: **Fast**

Infiltration: **None** Pipe Seal Cond: **Unknown**

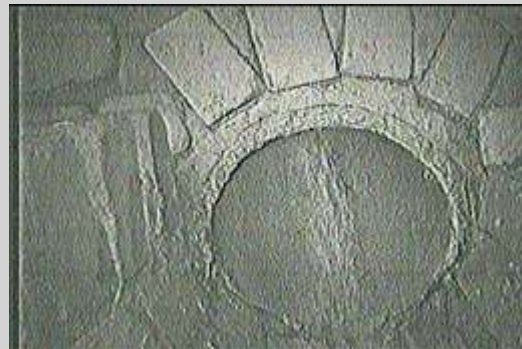
Drop In @ 4 O'Clock

Drop: **Outside** Rod and Bar

Angled: **Yes** Reading: **9.58** (ft.)

Inv Depth: **10.58** (ft.)

Drop Condition: **Open**

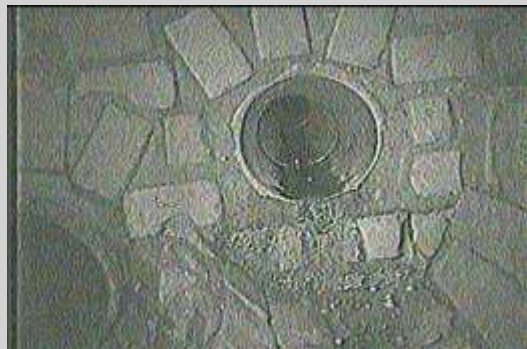
Pipe In @ 5 O'Clock

Pipe Material: **Clay**

Invert Depth: **10.16** (ft.) Flow Characteristics: **None**

Infiltration: **Evidence**

Pipe Seal Cond: **Unknown**
